BONTON ASSOCIATES

TECHNICAL  
MEMORANDUM IN  
SUPPORT OF  
CORRECTIVE ACTIONS  
FOR WATER SYSTEM  
IMPROVEMENTS

SUPPORT FOR TALLULAH, LOUISIANA  
MUNICIPAL WATER SYSTEM

PROJECT NO. 177180

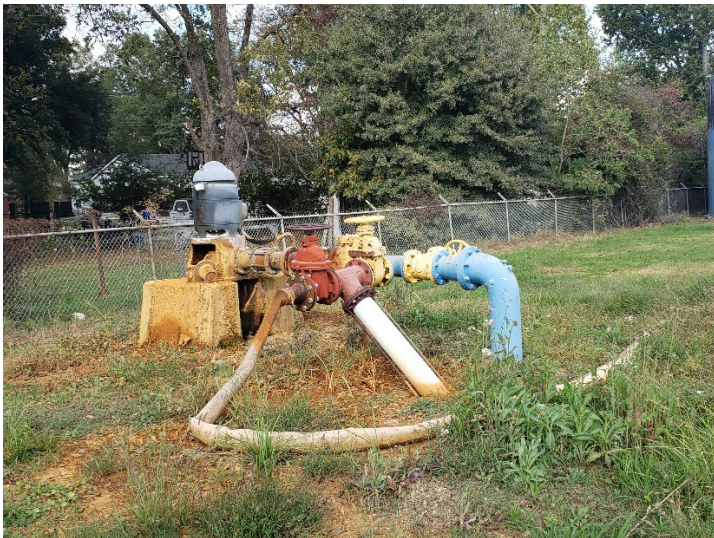
Figure 3: Well Head 2

- Well #2:
  - Item No. 55: Non-functional flowmeter needs to be replaced.
  - Item No. 56: The casings, motors, discharge piping, and upper well terminal of several wells are in poor condition due to heavy iron deposits, rust, and algae. These areas must be cleaned, evaluated for repairs, and recoated.

- Item No. 57: Well vent screens are rusty and need to be replaced. Screen must be 24 mesh wire; vent must be turned-downward and terminate at least 24-inches above ground surface level.

- Item No. 58: Broken or leaking sample tap.
  - Item No. 59: Pressure gauge on discharge needs to be added.
  - Item No. 71: Protective guards around the rotating shafts are missing. Belts, gears, rotating shafts, and electrical wiring should have proper shields to prevent injury.

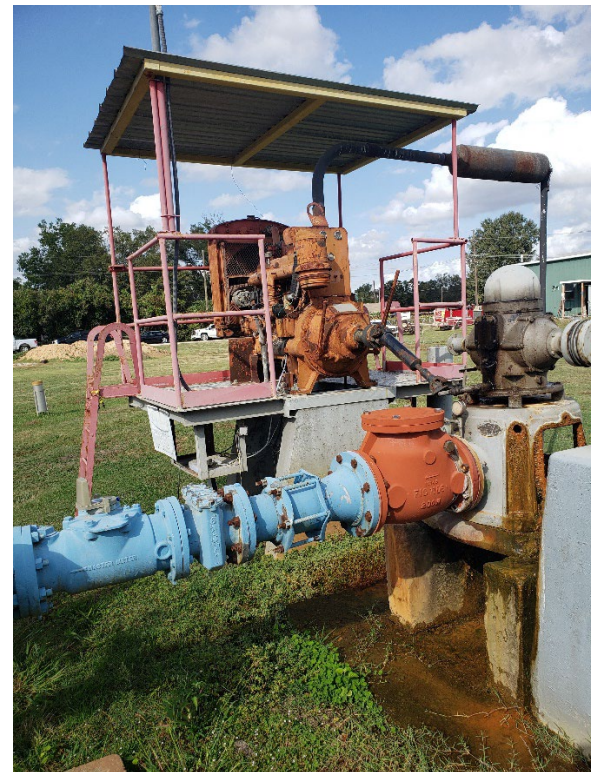
Figure 4: Well Head 3

- Well #3:
  - Item No. 60: Well vent screens are rusty and need to be replaced. Screen must be 24 mesh wire; vent must be turned-downward and terminate at least 24-inches above ground surface level.

- Item No. 61: The casings, motors, discharge piping, and upper well terminal of several wells are in poor condition due to heavy iron deposits, rust, and algae. These areas must be cleaned, evaluated for repairs, and recoated.

- Item No. 62: Well waste line is leaking.
- Item No. 63: Non-functional flowmeter needs to be replaced.
- Item No. 64: Packing is too loose causing the lubrication well to flood constantly. Tighten the packing to prevent flooding and deterioration of the well.

- Item No. 71: Protective guards around the rotating shafts are missing. Belts, gears, rotating shafts, and electrical wiring should have proper shields to prevent injury.

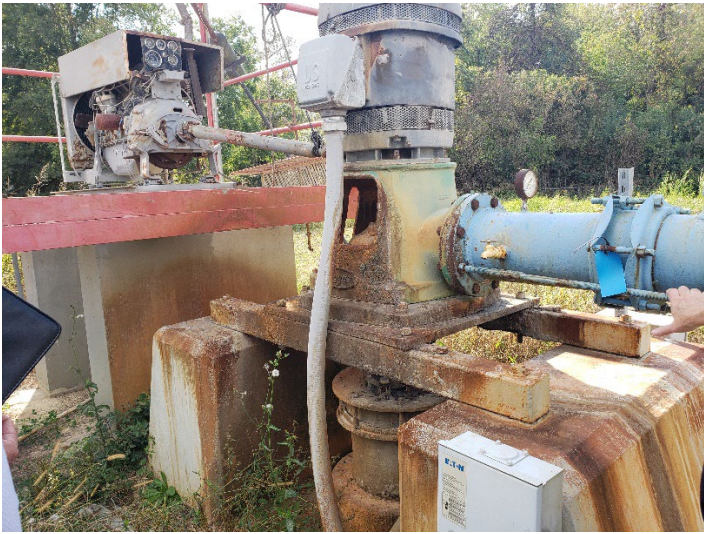
Figure 5: Well Head 4

- Well #4:
  - Item No. 65: Lantern rings are leaking and must be replaced.
  - Item No. 66: The casings, motors, discharge piping, and upper well terminal of several wells are in poor condition due to heavy iron deposits, rust, and algae. These areas must be cleaned, evaluated for repairs, and recoated.

- Item No. 67: Relocate the well vent to where the spray from the water lube does not wet the vent and cause it to become clogged. Well vent must be turned-downward and terminate at least 24-inches above ground surface level.

- Item No. 71: Rotating shafts are missing protective guards and must be installed. Belts, gears, rotating shafts, and electrical wiring should have proper shields to prevent injury.

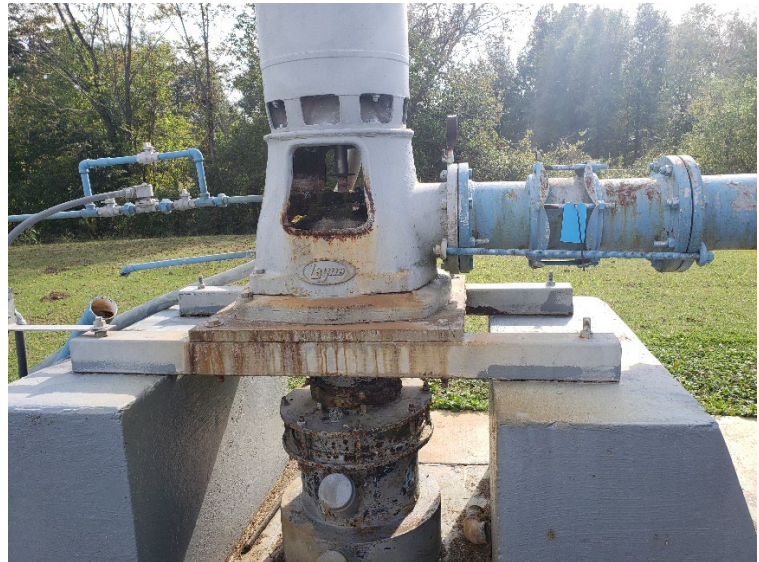
Figure 6: Well Head 5

- Well #5:
  - Item No. 69: Well vent water lubrication spray is causing the vent to become clogged and needs to be relocated. Well vent must be turned-downward and terminate at least 24-inches above ground surface level. The casing vent screen is missing and must be installed. Screen must be 24 mesh wire; vent must be turned-downward and terminate at least 24-inches above ground surface level.

- Item No. 70: The casings, motors, discharge piping, and upper well terminal of several wells are in poor condition due to heavy iron deposits, rust, and algae. These areas must be cleaned, evaluated for repairs, and recoated.

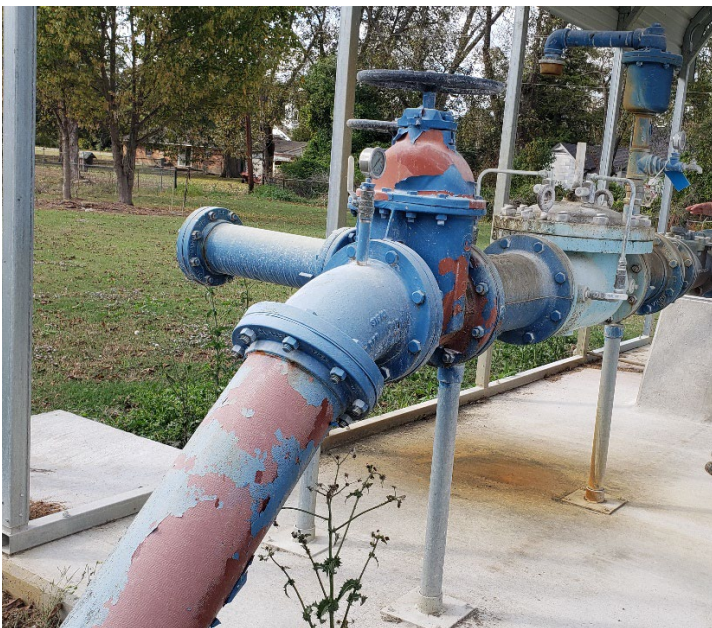
Figure 7: Well Head 6

- Item No. 71: Protective guards around the rotating shafts are missing. Belts, gears, rotating shafts, and electrical wiring should have proper shields to prevent injury.
- Well #6:
  - Item No. 72: The casing vent terminates immediately above the concrete slab. Well vent must be turned-downward and terminate at least 24-inches above ground surface level.

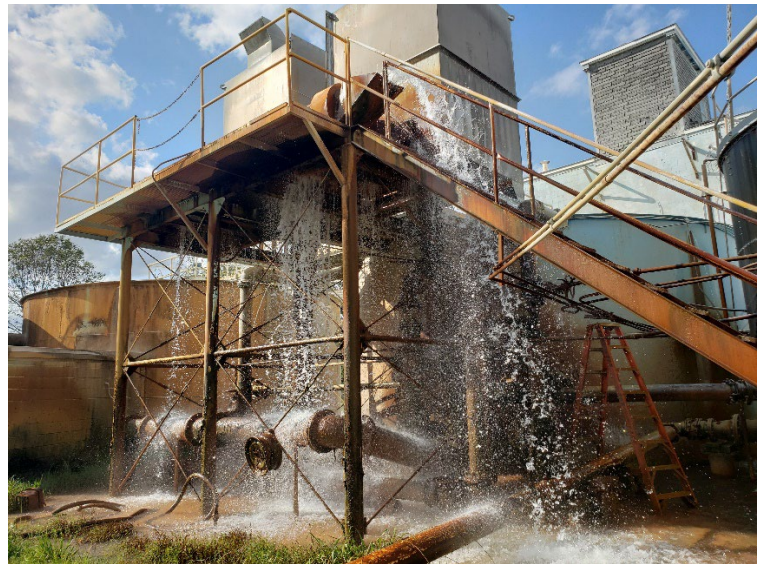
Figure 8: Aerators

The primary functions of aeration are to improve water quality by 1) removing dissolved gases such as carbon dioxide and hydrogen sulfide, and 2) oxidizing dissolved metals such as iron. The two aerators at the Tallulah WTP are currently receiving source water beyond the functional hydraulic limit of the equipment. Significant overflows and ruptures in the blower housing were observed, causing significant water loss. Due to significant corrosion and overall condition, it is anticipated that the blowers are not functional, and the aerators are likely not able to provide significant process benefit in their current state.

- Item No. 2: The aerator closest to the filter gallery was found to be leaking heavily.

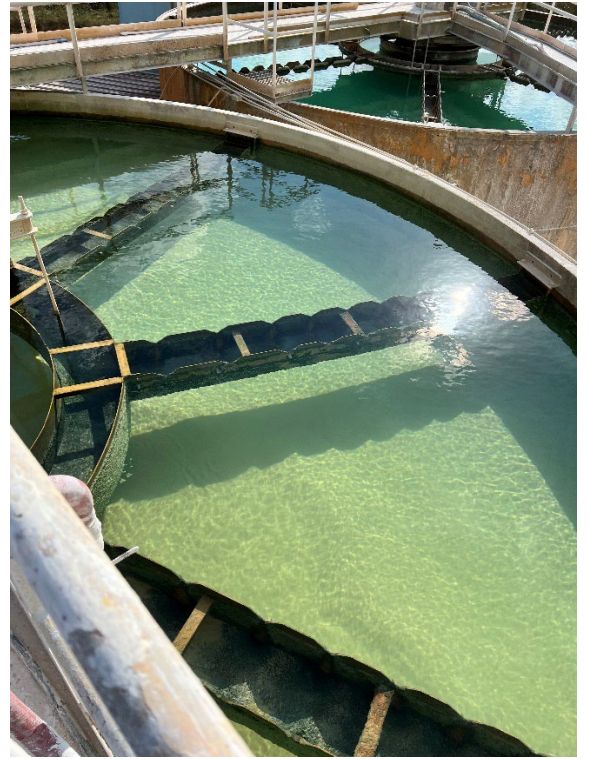
Figure 10: Solids Contact Clarifier #1

- Item No. 9: Clarifier #1 has a broken ball valve.
- Item No. 10: The Flash mixer for Clarifier #1 is non-functional.
- Item No. 11: Scraper drive for Clarifier #1 is non-functional.
- Item No. 12: The weirs of both Clarifier 1 and Clarifier 2 need cleaning.

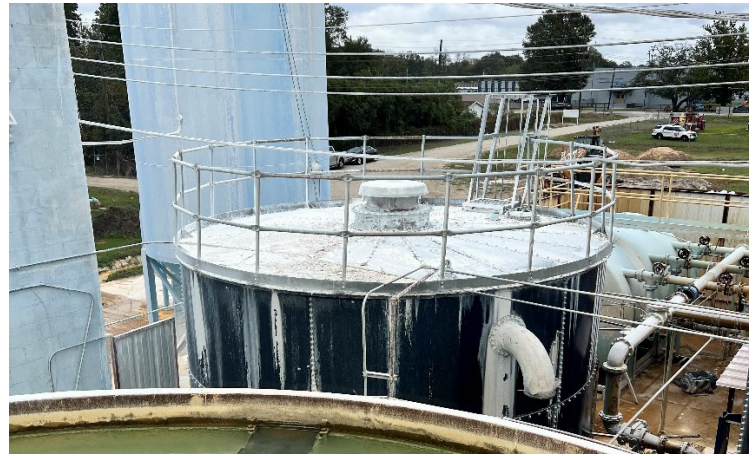
Figure 14: Intermediate Clearwell #1

- Item No. 45 & 47: The southeast and northeast clearwells (Intermediate Clearwell #1 and #2) are in poor condition due to lime scale, pinhole leaks (indicated by rust streaks), and rust. The clearwells must be cleaned and evaluated for repairs.
- Item No. 48: An open hatch on the southeast clearwell (Intermediate Clearwell #2) poses a contamination risk and must be kept closed.

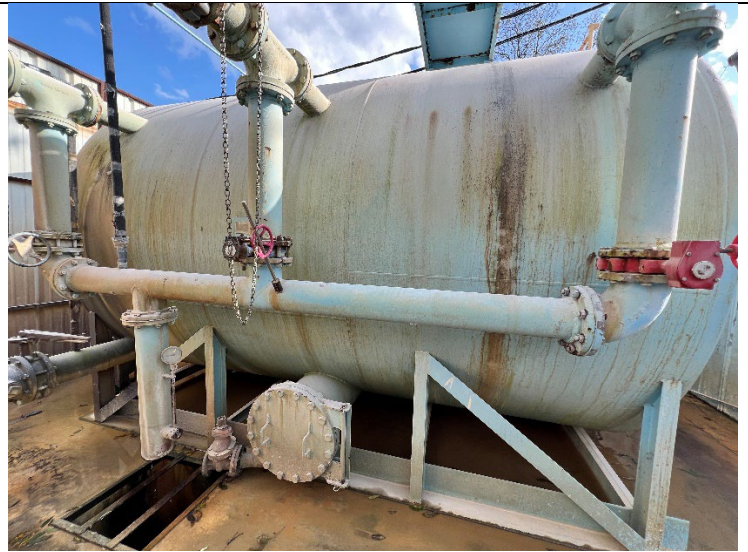
Figure 20: Pressure Filter #2

- Item No. 2: Filter #2 was leaking and rusting from the access ports.
- Item No. 51: The filter media for all filters requires inspection and potential replacement.
- Item No. 52: Many filter gauges for headloss / pressure differential are non-functional. This has resulted in staff backwashing filters on an arbitrary interval of 72 hours. The backwash pressure valves must be replaced.
- Item No. 53: There is a rupture in the steel vessel of Filter #4, which has put Filter #3 and Filter #4 out of service for an extended time, as the filters operate as a pair. There is a broken gate valve between Filters #1 and #2. There is a broken butterfly valve between Filters #3 and #4.
- Item No. 54: The backwash drain is constantly open during normal operations and the filter access hatches are leaking.

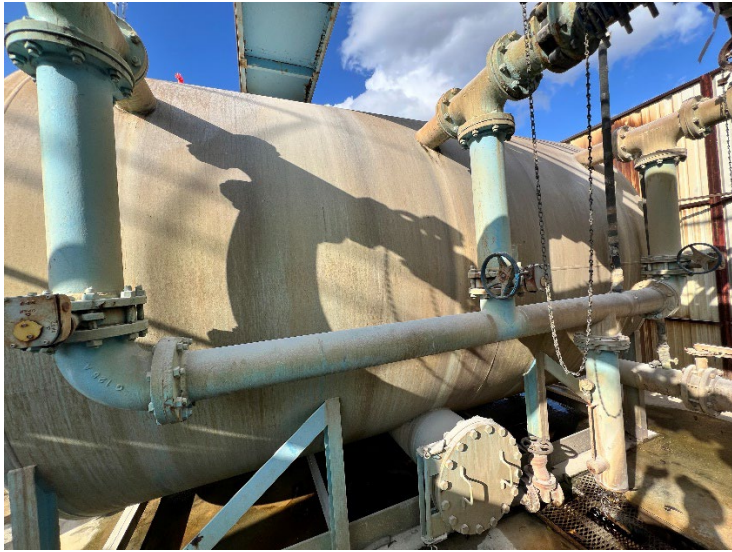
Figure 21: Pressure Filter #3

The purpose of the pressure filters at the Tallulah WTP is to remove suspended solids, particulate iron and manganese, natural organic material, bacteria, viruses, and other contaminants from the water. Pressure Filters #3 and #4 are completely offline, and the remaining two (2) cannot be taken offline for maintenance due to the demand of the water system. The two (2) offline filters are reportedly inoperable because of steel vessel rupture(s) caused by over pressurization of the filters in the past. Leaks were observed in the online filters at locations where severe metal corrosion on steel plating has occurred.

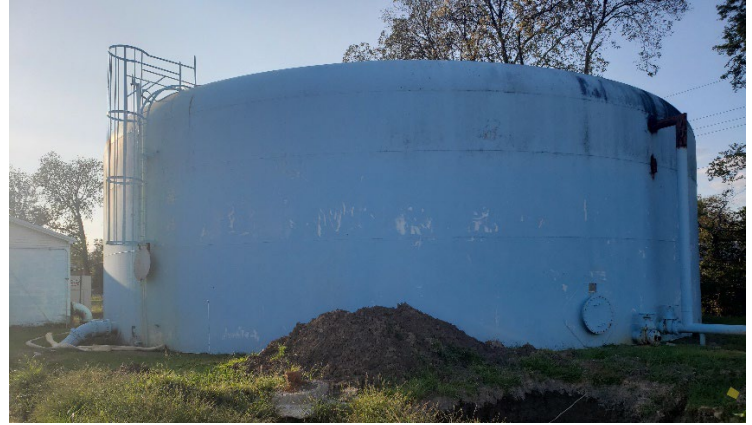
Figure 22: Final Clearwell (Ground Storage)

The ground storage tank (GST) at the Tallulah WTP receives effluent from the pressure filters and stores water before it is pumped to the distribution system from the high service pump station (HSPS). The exterior of the GST was in poor condition and there is a reported sunken portion of the tank which accumulates standing water and poses a risk to contamination of the finished water storage before entering the distribution system.

- Item No. 29: The access ladders are often left unlocked, posing security risks.
- Item No. 30: Drain valves are cracked and leaking.
- Item No. 31: Portions of the surrounding fence are missing, and vegetation is overgrown.
- Item No. 32 & 33: The tank's exterior paint is in poor condition, and tree roots have grown into the tank's base.
- Item No. 34 & 35: The overflow screen was broken, the roof was sagging, and the hatch was rusted.
- Item No. 36: The tank interior had not been inspected in several years.

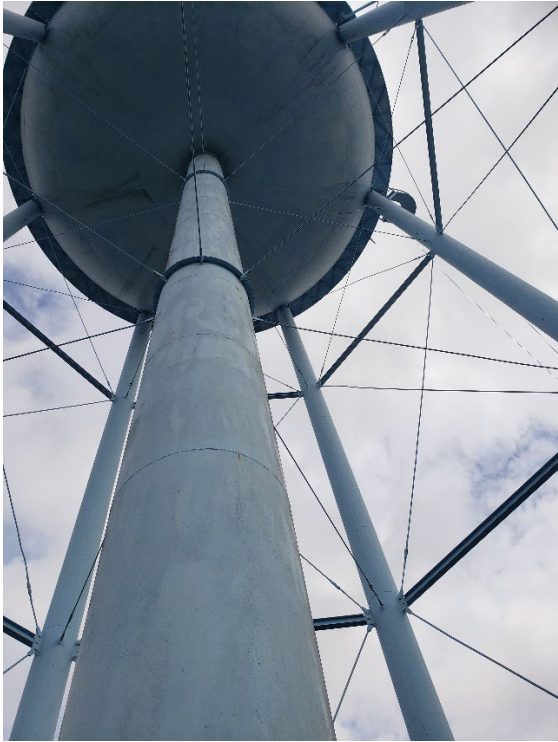
Figure 23: Elevated Storage Tank

The elevated storage tank aids in maintaining consistent pressure and supply throughout the distribution system. The elevated tank was not observed to provide any supplemental storage or pressure to the system during the low-pressure events when system pressure was less than 30 psi. This is due to the fact that the elevated tank requires approximately 58 psi to fill, based on the name plates at the elevated storage tank. Based on Burns and McDonnell's observations, which are further described in Appendix B, when HSP #2 is out of service there is not sufficient pressure with HSP #1 and #3 to fill the elevated storage tank.

- Item No. 23: There is erosion under the center riser column which must be investigated and remediated. Grading to slope away from the elevated tank center column needs to be evaluated.
- Item No. 24: The fence surrounding the tank is overgrown with vegetation and poses an issue for security.
- Item No. 25: The overflow screen is broken and needs to be replaced with a #4 mesh.
- Item No. 26: The sample tap is non-compliant, due to the presence of threading and a hose.
- Item No. 27: The pressure gauge used for measuring water level in the tank is broken.

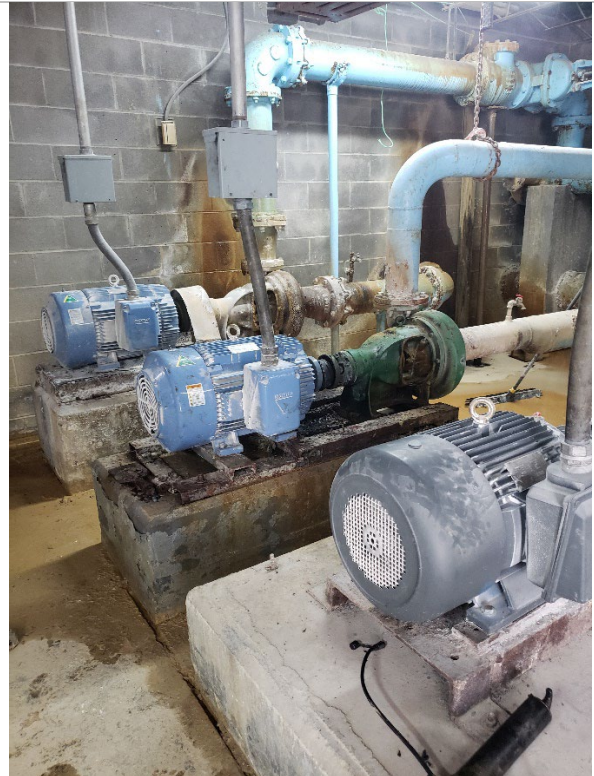
Figure 24: High Service Pumps

Past pump repairs and rebuilds indicated lime sludge carry-over into the pumps which is wearing out mechanical components and causing calcium deposit buildup. One (1) additional natural gas-powered backup pump is present in the HSP station, but it is not functional and has been out of service for several years.

- Item No. 37: Broken seal on High Service Pump #3.
- Item No. 38: Reliance on generator power without a secondary standby source.
- Item No. 39: Leaking valves.

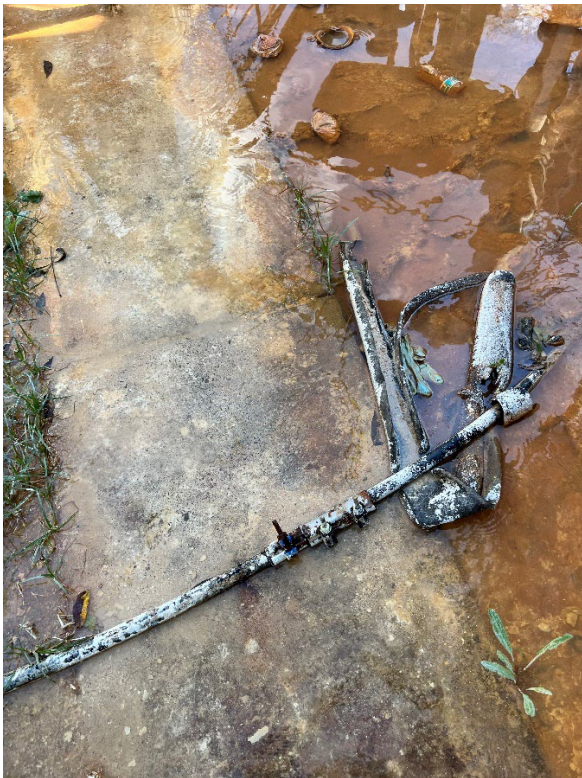
Figure 31: Chlorine Feed Line Underwater

The chlorine feed system consists of two (2) in-service 150-lb chlorine gas cylinders with vacuum regulators. The chlorine solution line exits the chlorine storage shed and is routed along the ground to Intermediate Clearwells 1 and 2. This solution pipe had previous repairs using pipe splices and other means and was observed to be submerged in standing water between the intermediate clearwells. At a gas feed of 108 ppd, the chlorine residual was measured on the filter effluent at 11.2 mg/L, which is believed to be the detection limit of the equipment used. This value in excess of the EPA's regulatory limit for chlorine residual which is 4.0 mg/L.
