BONTON ASSOCIATES

TECHNICAL  
MEMORANDUM IN  
SUPPORT OF  
CORRECTIVE ACTIONS  
FOR WATER SYSTEM  
IMPROVEMENTS

SUPPORT FOR TALLULAH, LOUISIANA  
MUNICIPAL WATER SYSTEM

PROJECT NO. 177180

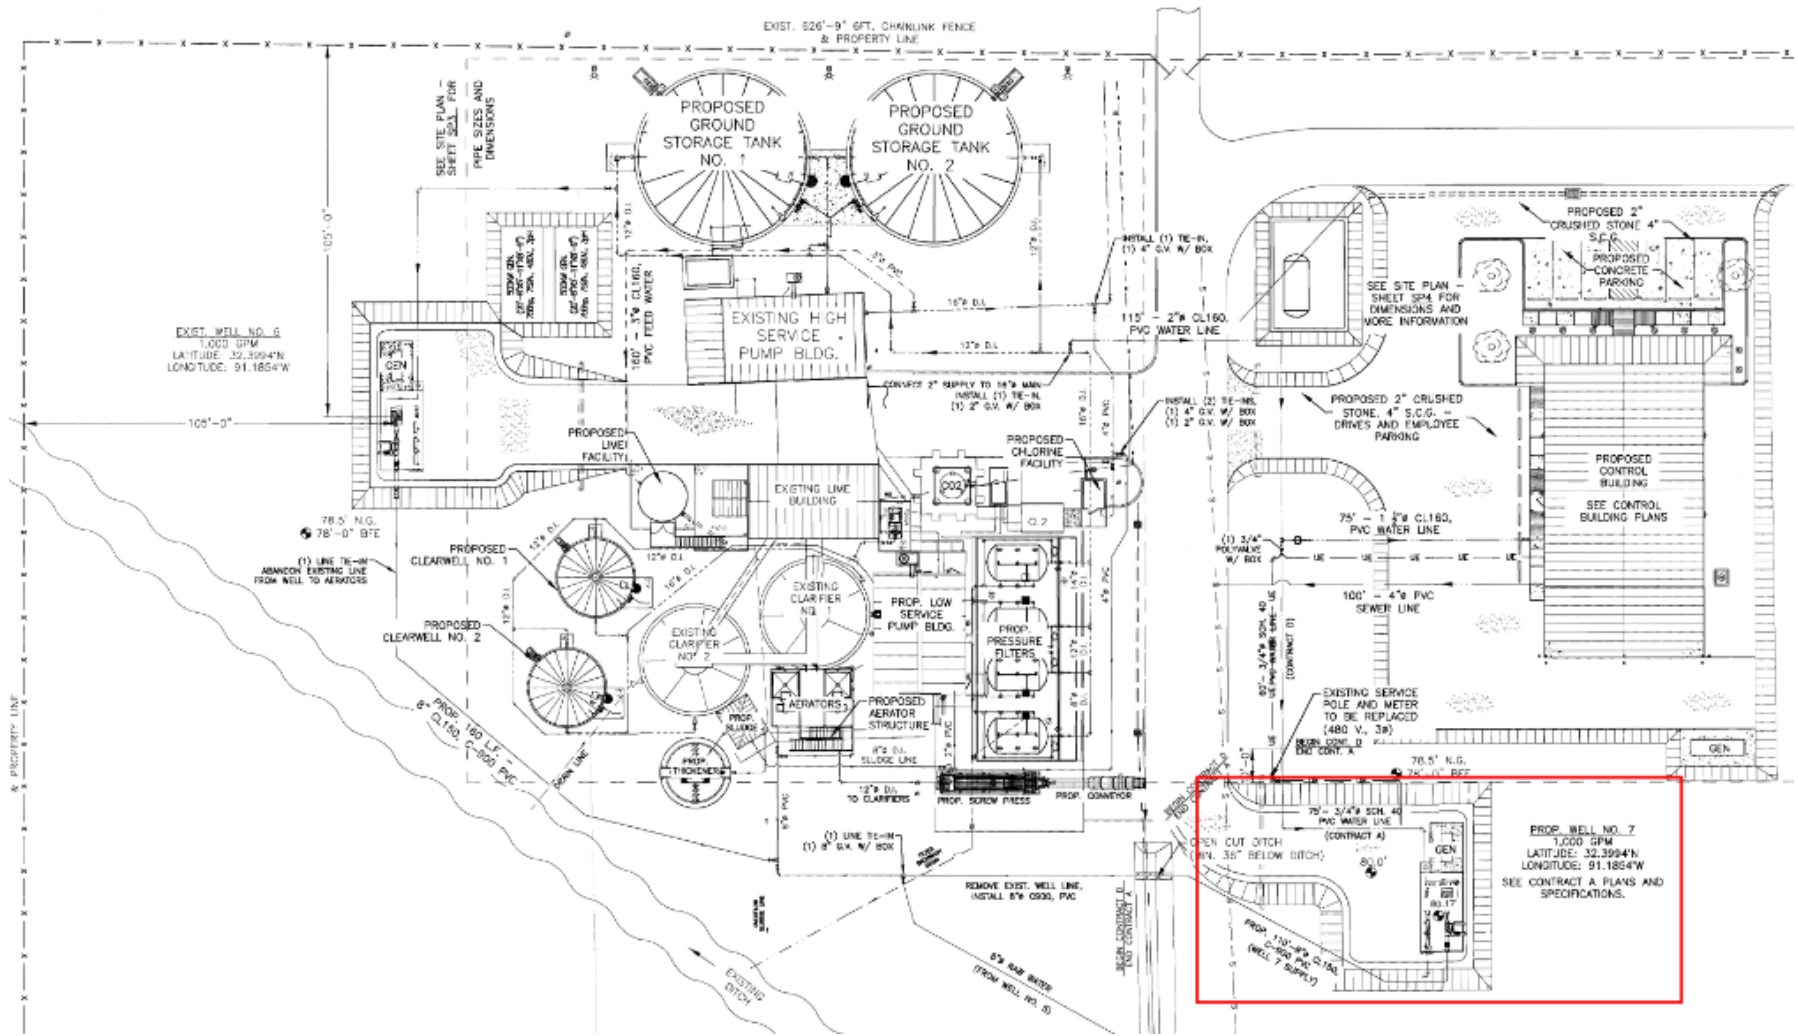
Figure 1: Proposed Location for New Well #7

Drilling a new Well #7 at WTP does not directly address any of the open violations; however, this CIP does allow for the City to abandon existing wells with open violations while adding redundancy and firm capacity. Corrective action against open violations will require a combination of CIPs and additional corrective actions and improvements, which are covered in the subsequent sections. The proposed location (by McManus Engineering) of Well #7 is shown in Figure 1.

Additional corrective actions will be necessary relating to any remaining in-service wells, which are assumed to be Well #5 and Well #6. Refer to Table 4 of Appendix A, Items No. 69 to 72. These actions are identified as CA-10 in Appendix C.

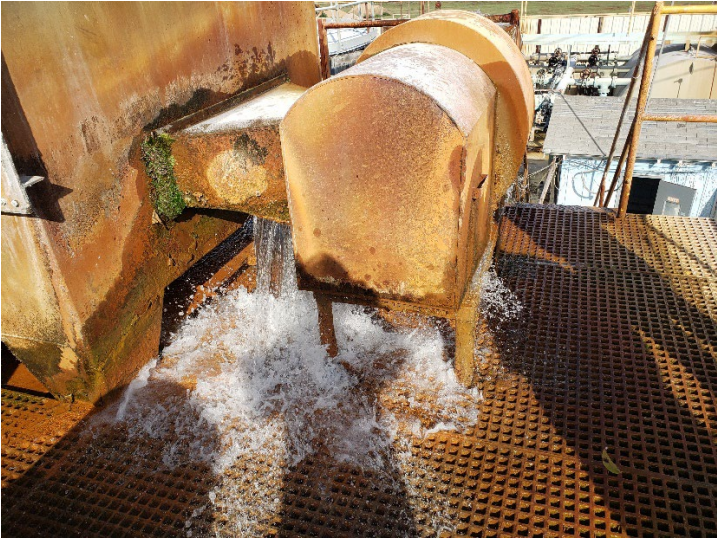
Figure 9: Aerator Blower

An aerator in a drinking water treatment plant is a device that introduces air into the water. The primary function of aeration is to improve water quality by 1) removing dissolved gases such as carbon dioxide and hydrogen sulfide, and 2) oxidizing dissolved metals such as iron and to a lesser degree, manganese. An aeration process helps to reduce unpleasant odors and tastes, lower the concentration of volatile organic compounds (VOCs), and enhance the overall effectiveness of subsequent treatment processes. The two aerators ([Figure 8](#) and [Figure 9](#)) at Tallulah WTP were receiving source water beyond the functional limit of the equipment. Significant overflows and ruptures in the blower housing were observed, causing significant water loss. Due to significant corrosion and overall condition, it is anticipated that the blowers are not functional, and the aerators are likely not able to provide significant process benefit in their current state.

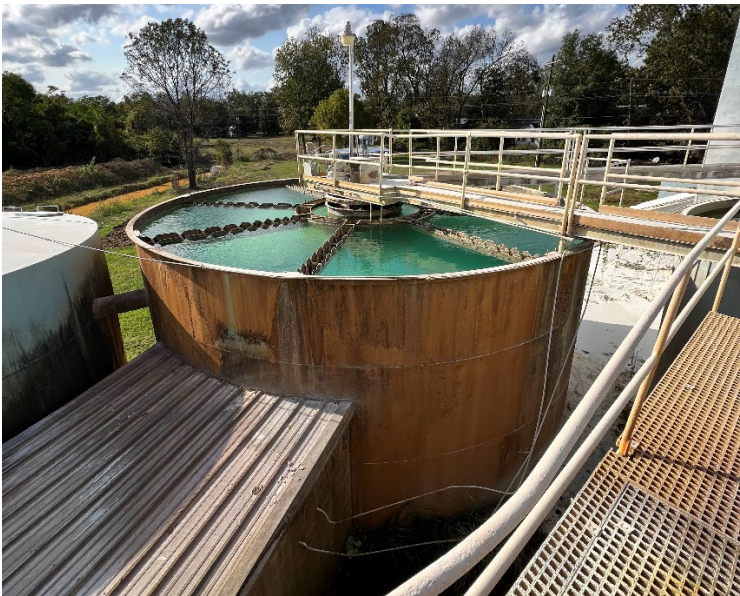
Figure 11: Solids Contact Clarifier #2

Solids contact clarifiers are used in drinking water treatment plants to enhance the removal of suspended solids and other impurities from the water. These units combine several processes, including chemical treatment, mixing, flocculation, and sedimentation into a single unit. The primary function of a solids contact clarifier is to improve water quality by settling out suspended solids, reducing turbidity, and removal of hardness, metals, and other contaminants. Plant staff reported that the two (2) solids contact clarifiers at Tallulah WTP must remain in service at all times due to demands of the City's water system. Based on discussions with plant staff, Burns & McDonnell noted that training is required for plant staff to learn how to isolate the clarifiers for cleaning and maintenance. The two (2) clarifiers are above-grade steel tanks and are shown in [Figure 10](#) and [Figure 11](#). The clarifiers each have a volume of 76,000 gallons.

- Replace the existing clarifiers with new basins and clarifiers mechanisms – the clarifier steel tanks are in poor condition, and the structural integrity of the remaining steel plates is unknown.

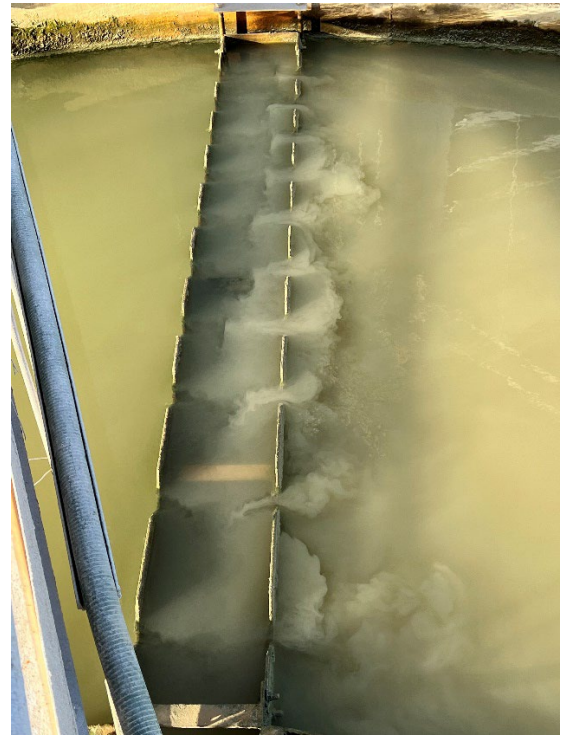
Figure 12: Solids Contact Clarifier #1 Launderers

Per conversations with plant staff, lime dosing is adjusted based on the effluent pH from the clarifiers, with a target effluent pH of 10.2. During Burns & McDonnell site visit the feed setting on the lime auger was at maximum dose rate. The effluent launders of each clarifier feed into outlet pipes which connect to the intermediate clearwells ([Figure 12](#) and [Figure 13](#)). Both Clarifiers 1 and 2 were observed in operation with sludge blankets near the bottom of the effluent launders. On the first day of observation, the sludge blanket in Clarifier 1 was approximately one to two feet below

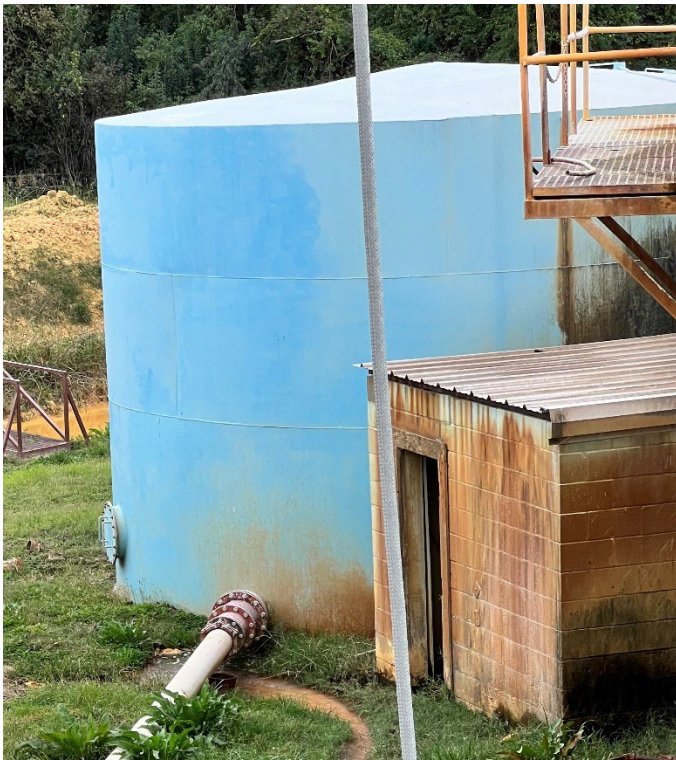
Figure 15: Intermediate Clearwell #3

The intermediate clearwells at the Tallulah WTP are used to hold the clarifier effluent water temporarily before it undergoes further treatment. The primary function of these clearwells is to provide contact time for disinfectants to inactivate any remaining pathogens. There are three (3) steel above-grade intermediate clearwells at Tallulah WTP. Each clearwell has a volume of 25,000 gallons and are housed in steel tanks. Clarifier 1 effluent flows directly into Intermediate Clearwell 1 (Figure 14). Clarifier 2 effluent flows directly into Intermediate Clearwell 3 (Figure 15 and Figure 16). Intermediate Clearwells 1 and 3 converge into Intermediate Clearwell 2 (Figure 17). The effluent of each clearwell is near the bottom of the tanks, which may be contributing to sludge carry over present in the pressure filters (per plant staff).
